# Zirconia Implants and All-Ceramic Restorations for the Esthetic Replacement of the Maxillary Central Incisors

**Josep Oliva, MSc**

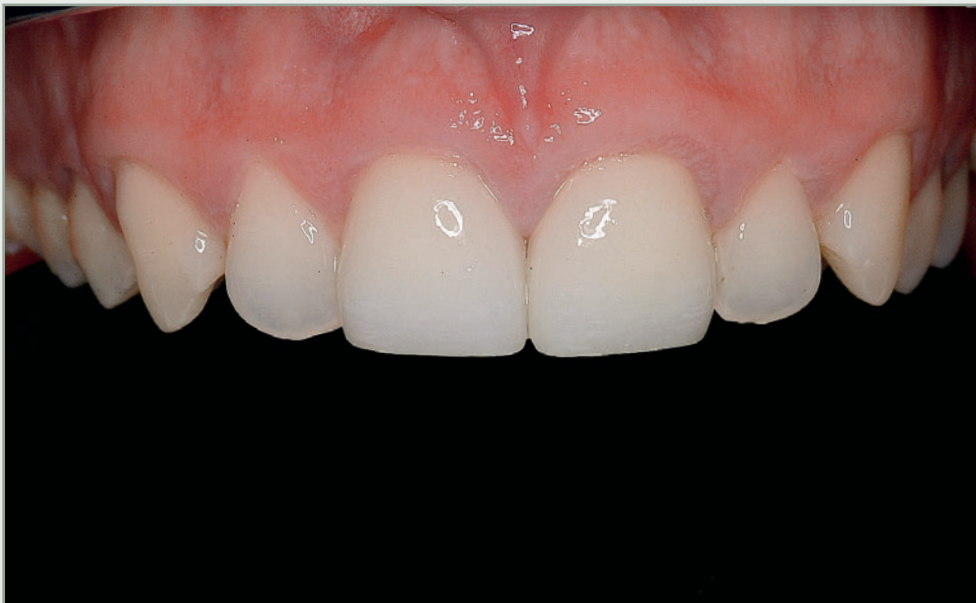
*(Eur J Esthet Dent 2008;3:174–185.)*

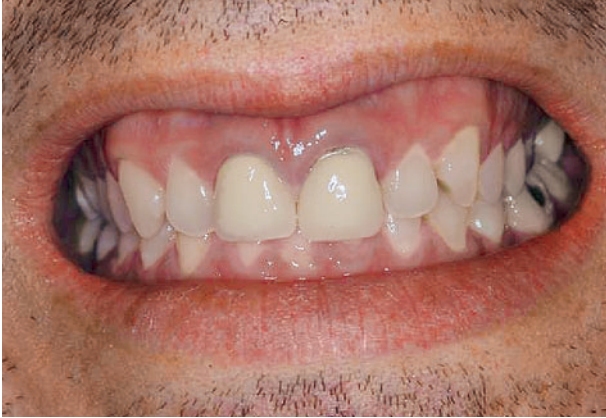
**Fig 1** The patient had a high smile line, with dark coloration visible through the gums.

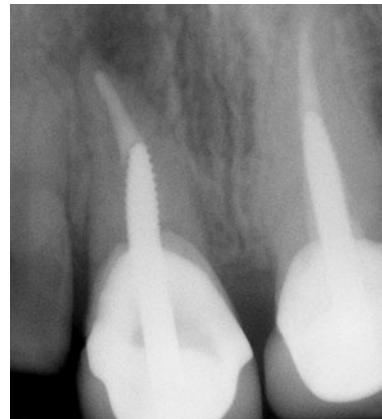
**Fig 4** Radiograph showing the periapical lesion at the left central incisor.

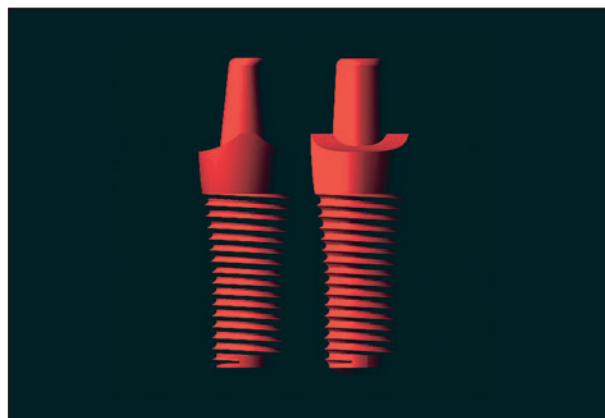
**Fig 5** Frontal (left) and interproximal (right) views of the CeraRoot zirconia implant.

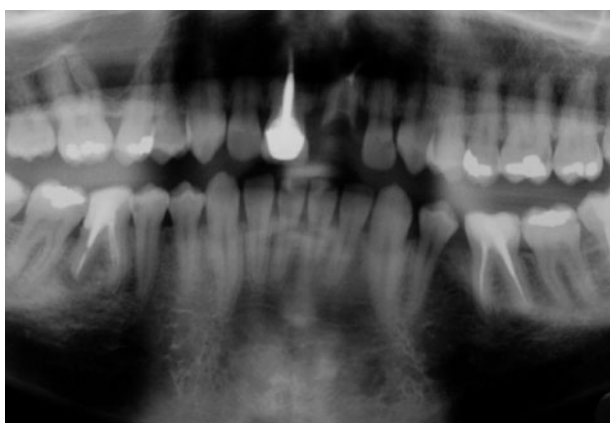
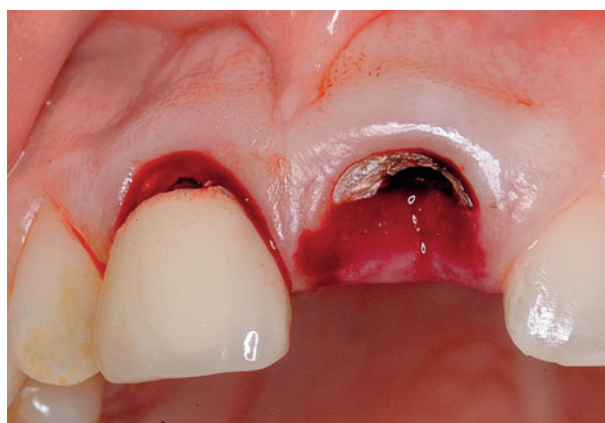
**Figs 6 and 7** Radiograph and intraoral view following extraction of the left central incisor.
