Biomechanical and Clinical Attributes of Zirconia Dental Implants — Two Case Reports

Dan Hagi DDS, FAGD, FICOI, (A)FAAID

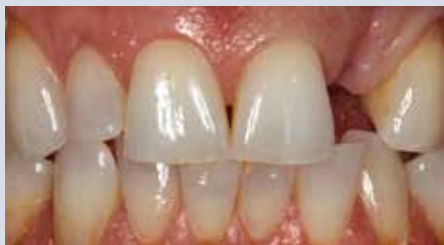
FIGURE 1—Pre-operative condition.

keratinized, with a small buccal deficiency (Figs. 1-3). Occlusion was stable and even though tooth #32 was in buccal version, enough restorative space was available. Some recession was noted on her upper canines with otherwise healthy periodontal tissues. The smile line was high and a highly aesthetic outcome was desired.

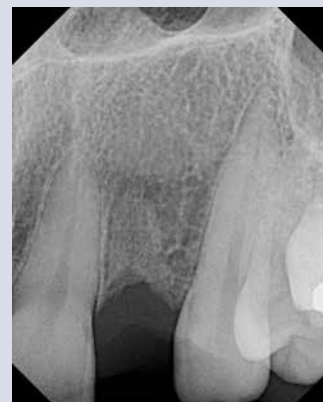
FIGURE 3—Pre-operative radiograph.

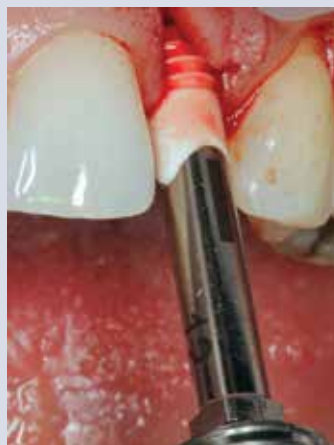
FIGURE 5—Implant being inserted with stainless steel driver.

CeraRoot 12 of 12 mm length (indicated for upper laterals) implant was selected for this case. The implant was placed (Fig. 5) at 30Ncm of initial stability with the buccal restorative margin placed where desired, about 0.5mm below the gingival margin (Figs. 6 & 8). Absorbable sutures (Coated Vicryl, Ethicon) were used to stabilize the flap and

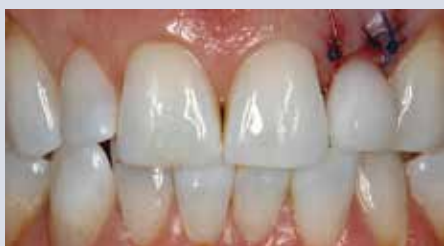
FIGURE 7—Provisional crown cemented immediately after surgery.

an immediate provisional crown was fabricated out of a bisacryl (Luxatemp, DMG-America) and cemented with a small amount of provisional cement (CLING2, Clinician's Choice Dental Products, Inc.) (Fig. 7).

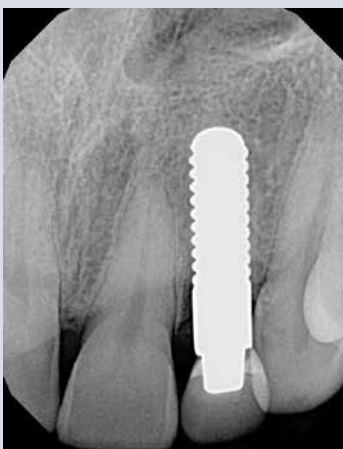
FIGURE 8—Post-operative radiograph.

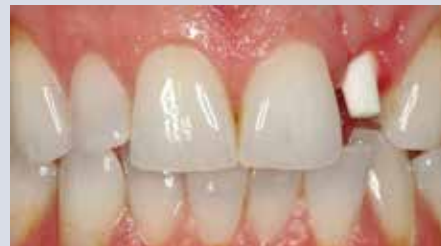
FIGURE 9—Healed implant three months post surgery.

After three months of healing the soft tissue healed and the implant integrated and was now ready for final restoration (Figs. 8-11). A digital scan utilizing iTero (Cadent, NJ) was taken and an E.max crown was lab

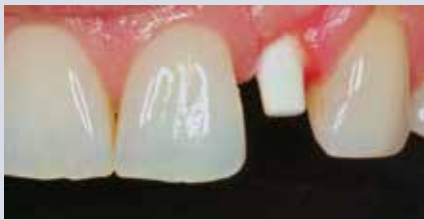
FIGURE 10—Healed site up close showing soft tissue overgrowth.

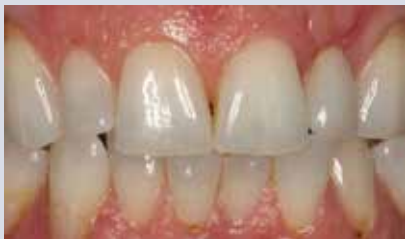
FIGURE 13—Day of cementation of final crown.

fabricated. The crown was tried in and inserted with a composite resin cement (Maxcem Elite, Kerr Dental) (Fig. 13). Occlusion was adjusted as to avoid lateral contacts. Special attention was made to adjust the final occlusion of the crown slightly in infra-occlusion, avoiding lateral contacts and the anterior guidance. This is important to compensate the elasticity of the periodontium of the neighboring teeth, in contrast of the rigidity of the ceramic implant and crown. The final result, one year after function, shows healthy soft tissue without any signs of inflammation around the CeraRoot acid-etched surface (Fig. 14). Moreover, the periapical radiograph shows that bone is stable around the implant and there is no evidence of early bone remodeling.

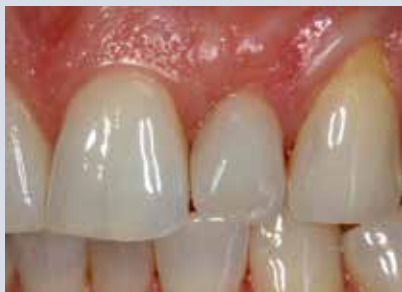
FIGURE 14—One-year in function.

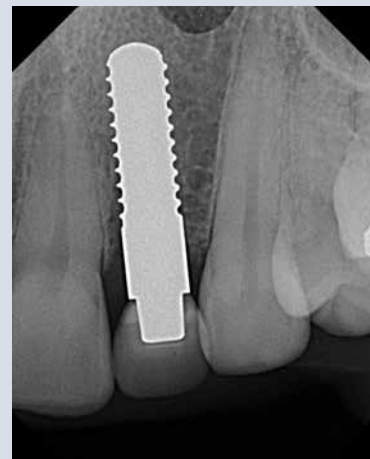
FIGURE 12—Three-month radiograph. Nearly no bone remodeling is seen.

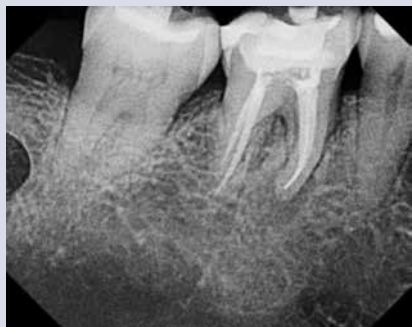
FIGURE 15—Pre-operative radiograph.

the tooth has been feeling tender for about two years ever since the endodontic treatment was completed. Radiographic and clinical exam revealed a fractured instrument in the mesial canal (Fig. 15) and a possible vertical root fracture. Class II stable occlusion was noted. Buccal recession was evident in both upper and lower teeth with thin scalloped tissues, otherwise healthy periodontal tissues.

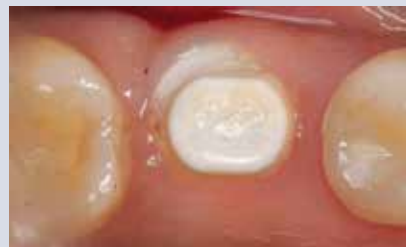
FIGURE 17—Occlusal view — note the soft tissue overgrowth.

After four months of uneventful healing, the soft tissue matured and was ready for restoration (Figs. 16, 17). The soft tissue overgrew the restorative margin of the implant and as such a laser (Picasso, AMD Lasers) was used at 2.0W pulsed to expose the margins (Fig. 18) and a digital scan utilizing iTero (Cadent, NJ) was taken. A Prettau (Zirkonzahn, Gais) zirconia crown was made with zirconia in all functional areas and porcelain added on the

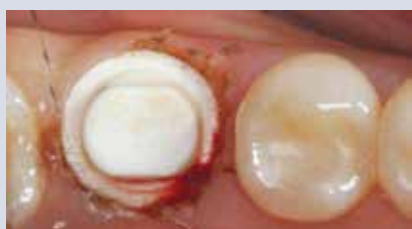
FIGURE 18—Margin exposed with soft tissue laser.

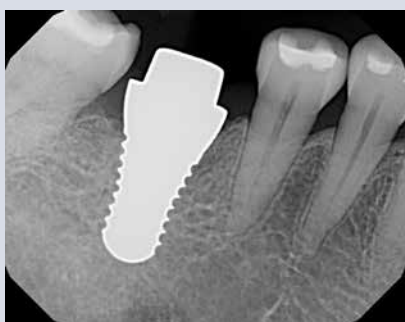
FIGURE 19—Radiograph showing bone volume after four-months of healing.

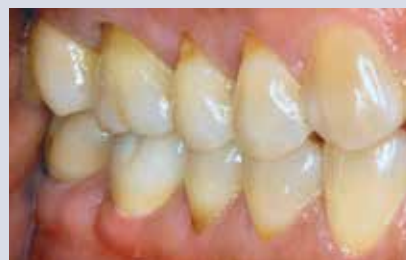
FIGURE 20—Final crown cemented, perfect prosthesis integration

buccal of the crown for aesthetics (Figs. 20, 21). The crown was tried in and inserted with a composite resin cement (Maxcem Elite, Kerr Dental). Occlusion was adjusted as to avoid lateral contacts.

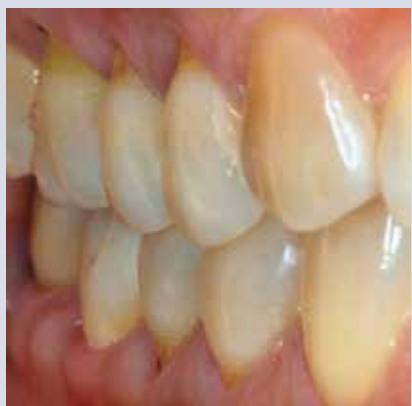
FIGURE 21—Beautiful soft tissue profile
